# Study of Adding Reflective Materials to Crossing Signs and Posts

Prepared by  
Transportation Development Centre  
Safety and Security  
Transport Canada

November 1997 (revised edition July 1999)

CDT 9103

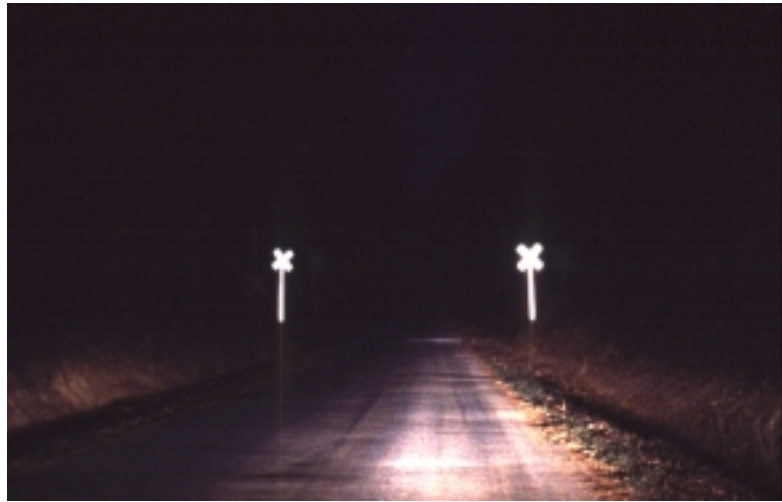
**EXHIBIT 5**

Virginia Reflectorized Railroad Crossing Sign and Post

Eastbound, low beam, 200 ft. (61 m)

Exhibit 5 shows the system recommended by the Virginia study.

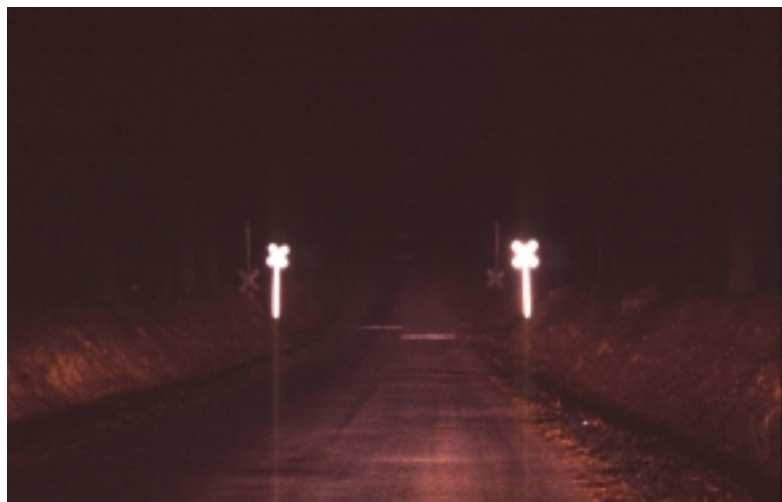
Eastbound, high beam, 200 ft. (61 m)

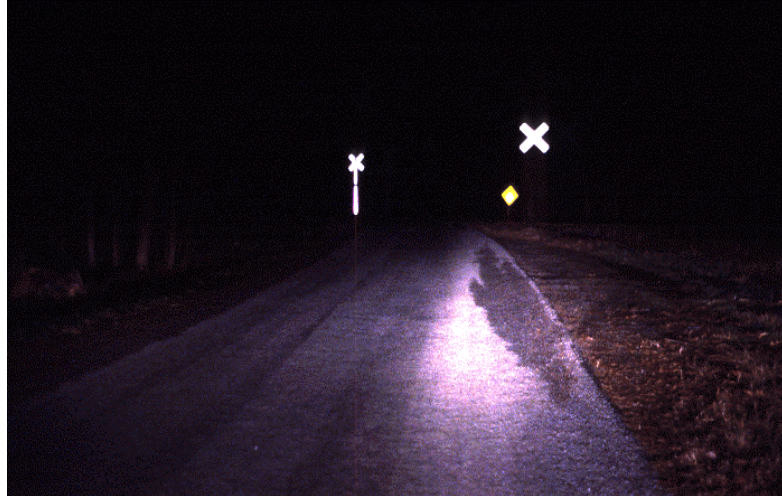
**EXHIBIT 7**

Photograph of Demonstration by Virginia Research Showing the Effect of Reflectorizing Only the Back Side of the Sign and Post

Visibility of the whole crossing is lowered when the front of the post is not reflectorized.

Both the Kansas and Virginia studies recommend reflectorization of the full length of the front and the back of the posts and the front and the back of the crossbuck. The Virginia study finds that the visibility of the entire crossing suffers when the back of the far side post is reflectorized but the front of the near side post is not. This phenomenon is shown on the Exhibit 7.
